Monuments at Risk?

Mapping threats to heritage assets on the Malvern Hills: The British Camp Hillfort Survey

June 2015

Dr Jodie Lewis and Cat Lodge,
Institute of Science and the
Environment,
University of Worcester

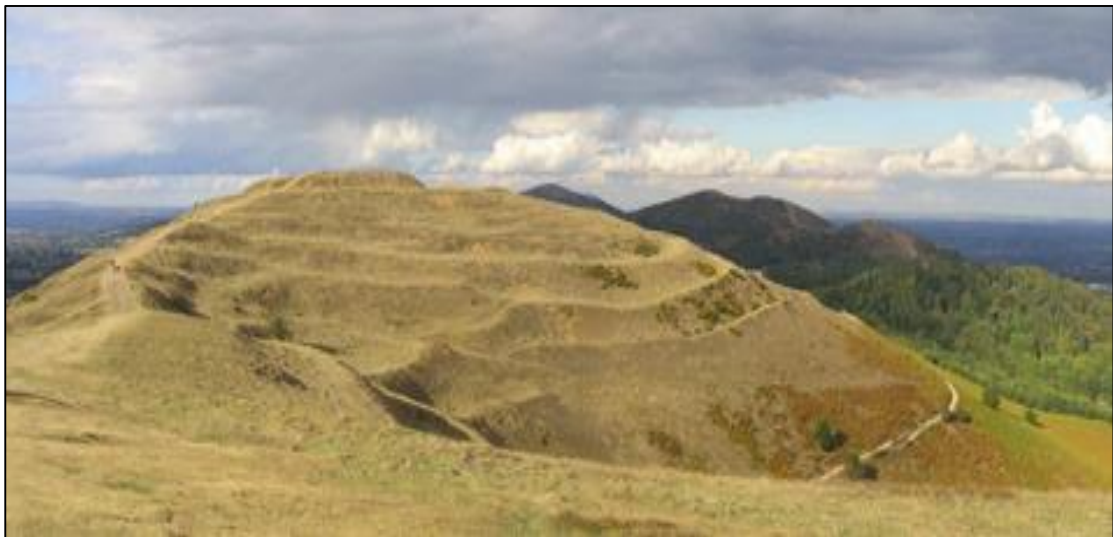
Figure 4: View of Herefordshire Beacon/British Camp Hill Fort (Malvern Hills AONB 2015)

The Citadel (or Herefordshire Beacon Ringwork) dates to the medieval period and consists of a ringwork and bailey, with possible signs of a stone gateway on the bailey. The central enclosure is a ring motte, presumably of 12th century date (Herefordshire Through Time 2010). The ringwork itself has an interior platform surrounded by a rampart and is morphologically of medieval date (Bowden 2005), and appears to range from the 11th century to the 14th century. The ringwork can be seen as the uppermost earthwork in figure 4.

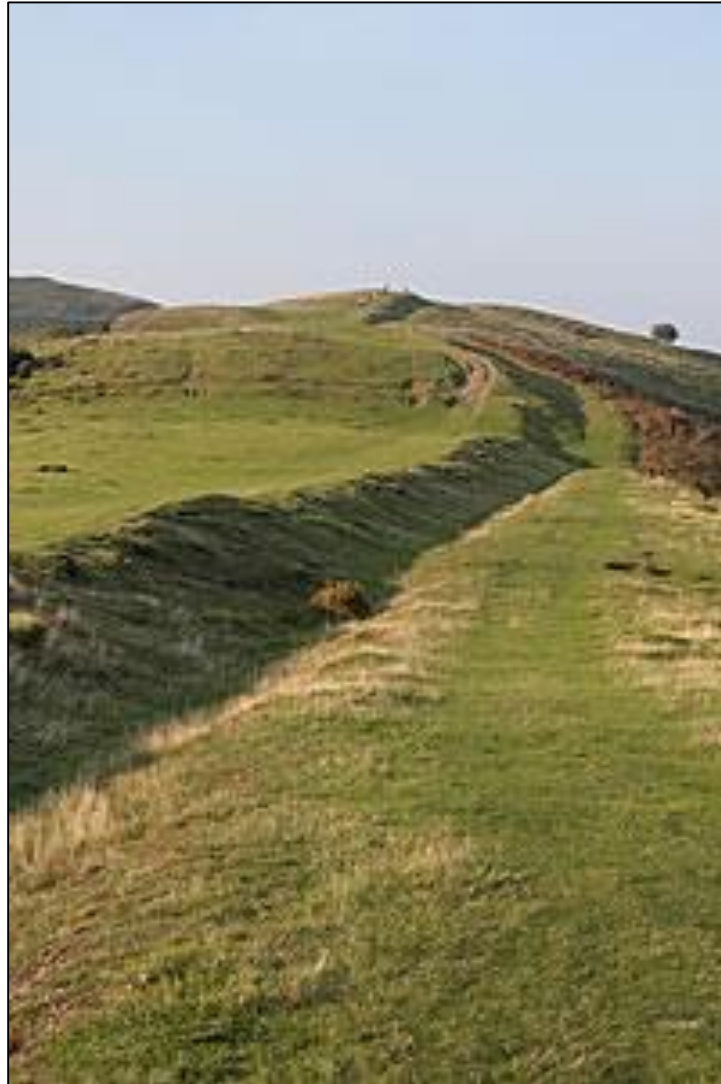
Figure 5: The Shire Ditch (Malvern Hills Conservators 2010)

The Shire Ditch (Scheduled Ancient Monument 244) is a linear boundary that runs along most of the principal ridge of the Malvern Hills (figure 5). Due to its relationship with Midsummer Hill, it is thought by some that its origin may be prehistoric, and Hooke's work (1985; 1990), cited by Bowden (2005) suggests that it was a significant feature in the landscape in the Anglo-Saxon period.

Since the 10th century AD, the Shire Ditch has functioned as an estate boundary as well as the diocesan boundary between Hereford and Worcester. The Shire Ditch's relationship with British Camp shows that here at least it post-dates the hillfort (Bowden 2005; Herefordshire Through Time 2010).

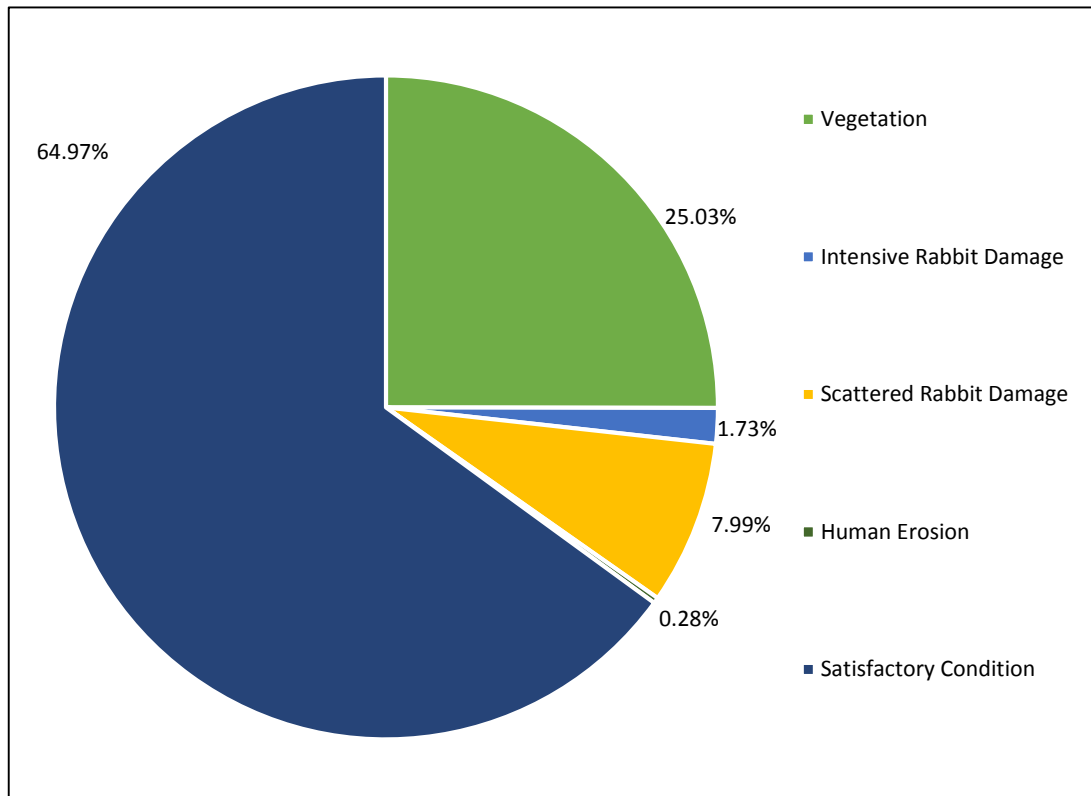
Figure 6: Proportion of threats by total area of hillfort

Almost 65% of the monument is deemed to be in satisfactory condition. Vegetation accounts for the largest proportion of threats, covering 25% of the monument, predominantly on the lower ramparts. Significant erosion caused by rabbit activity affects almost 10% of the study area. Anthropogenic damage is minimal in comparison to these two categories but many of the threats overlap and are exacerbated by each other.

A survey carried out in 2013-14 by the Malvern Hills AONB showed that it was believed 100% of the scheduled monuments across the Malvern Hills were in 'satisfactory condition' (2014), and had improved from the 2008 trend of 63%. Based on the results of this report it is evident that the headline indicator of the AONB report may need revisiting, as only 65% of the monument was deemed to be in satisfactory (that is, "unthreatened") condition (figure 6).

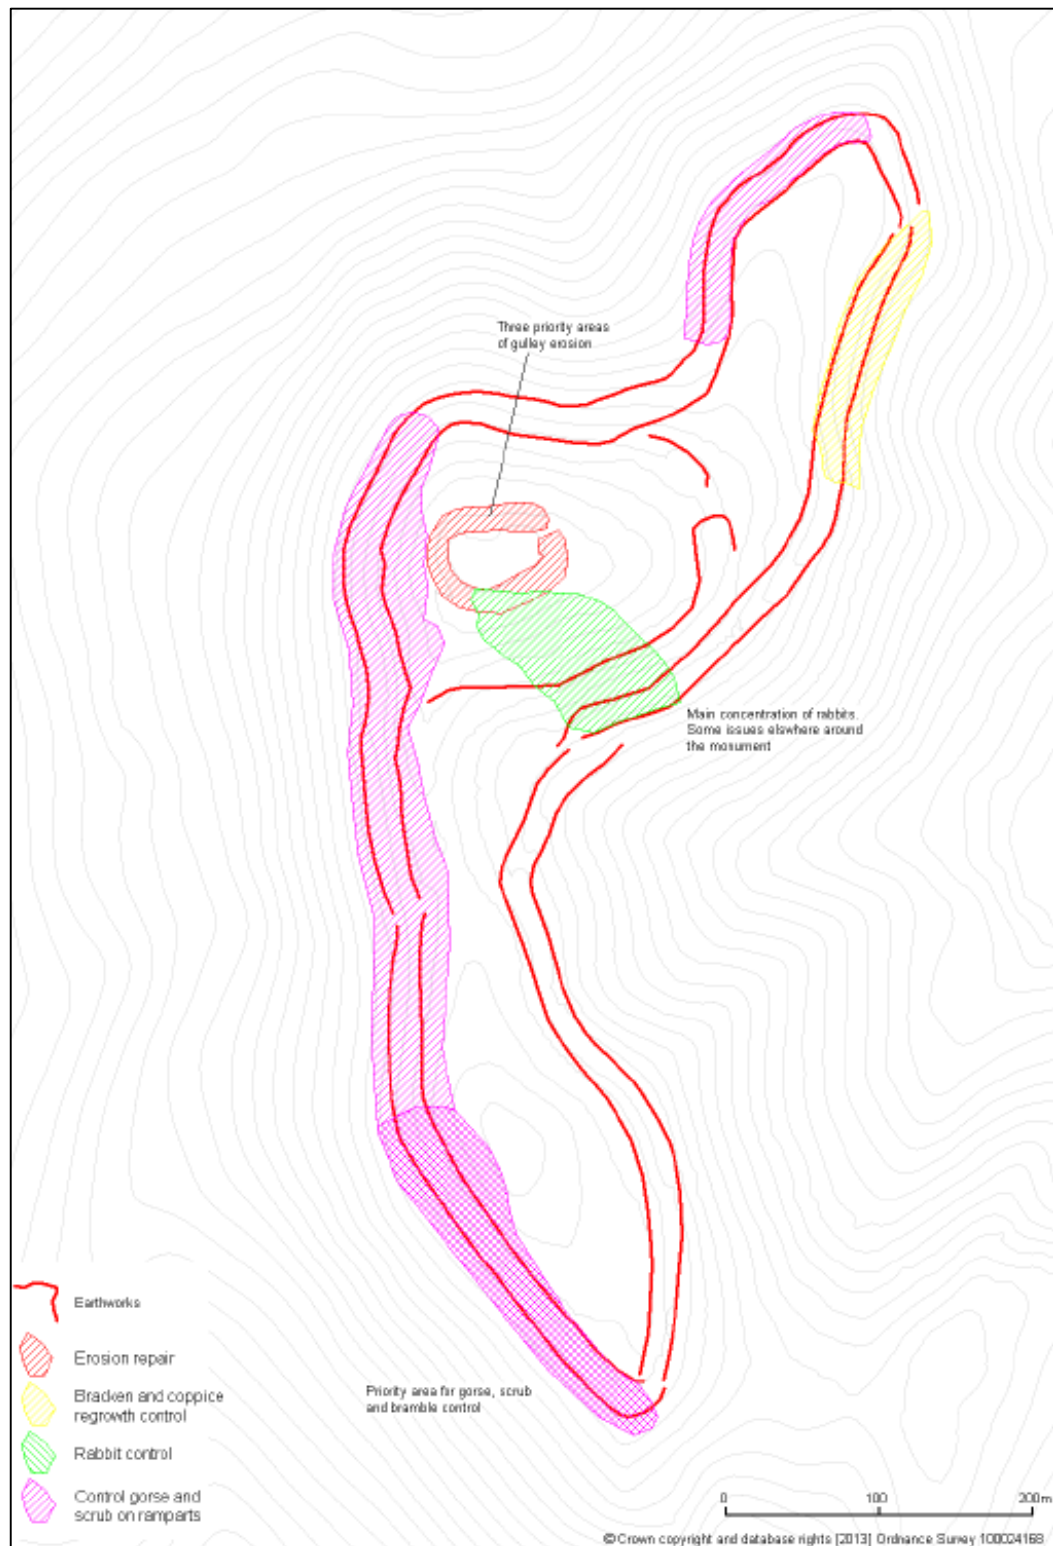
Figure 7 is taken from Dorling's 2013 report and is a summary of vegetation and erosion management issues. This will be used for comparison with the final composite map produced for this study.

Figure 7: Summary of vegetation and erosion management issues in Herefordshire Council CMP (Dorling 2013, 53)

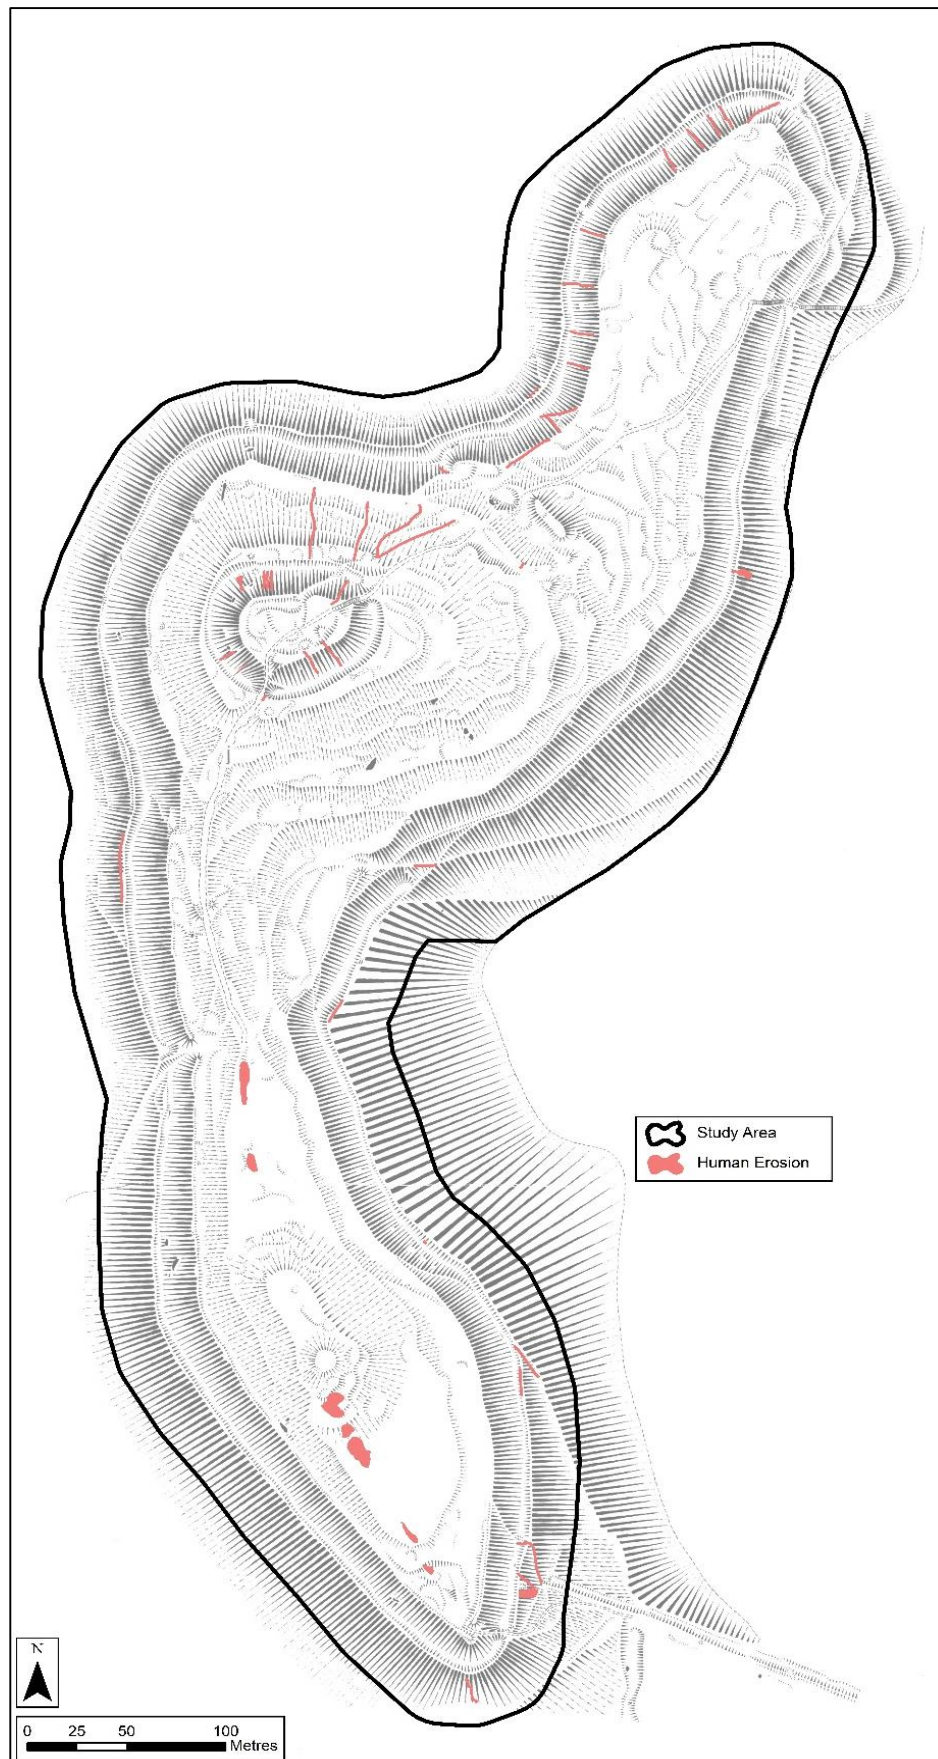
Figure 8: Areas of Human Erosion. Metric survey copyright Bowden 2005.

The results of the GPS survey clearly identify the main areas of damage as a result of human erosion (figure 8) as concentrated around the lower ramparts of the monument.

Significant erosion caused by human activity has also been recorded along the path between Millennium Hill and Herefordshire Beacon, and at the south-eastern end and the summit of Millennium Hill (figure 8).

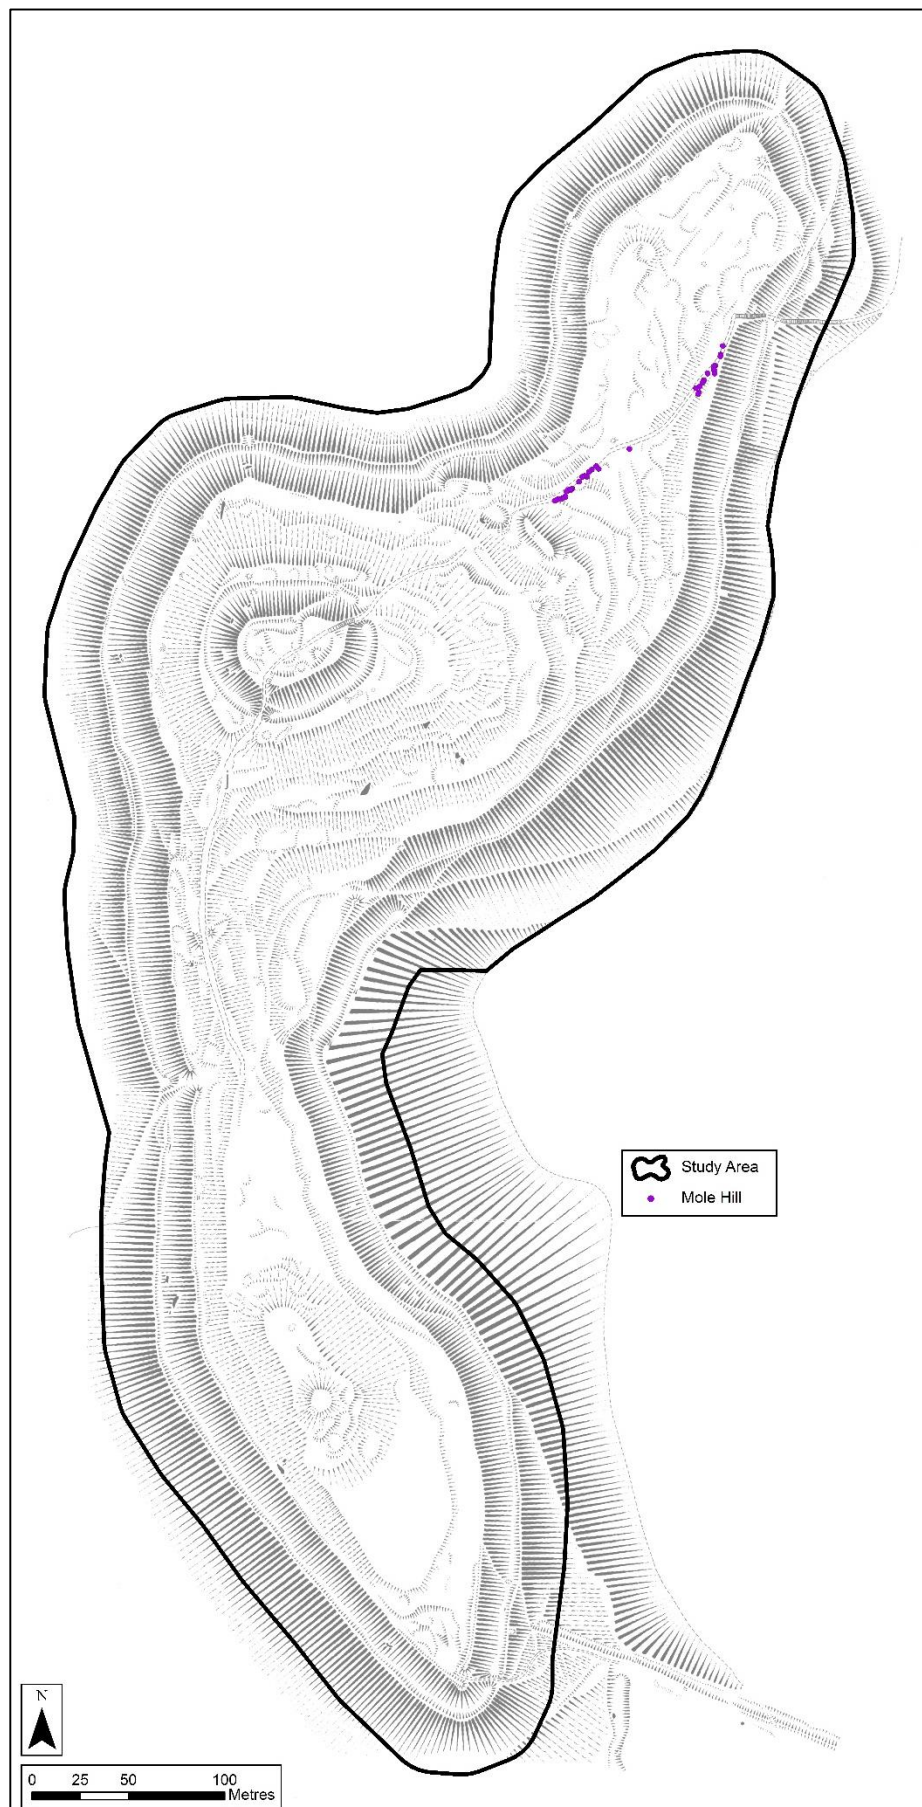
Figure 9: Survey Results of Molehills

Figure 9 illustrates the areas of molehills recorded, and it is apparent that the majority of resultant damage from this category is to the north east of the ringwork of British Camp. The molehills appear to run parallel to the main footpath from the car park (figure 22).

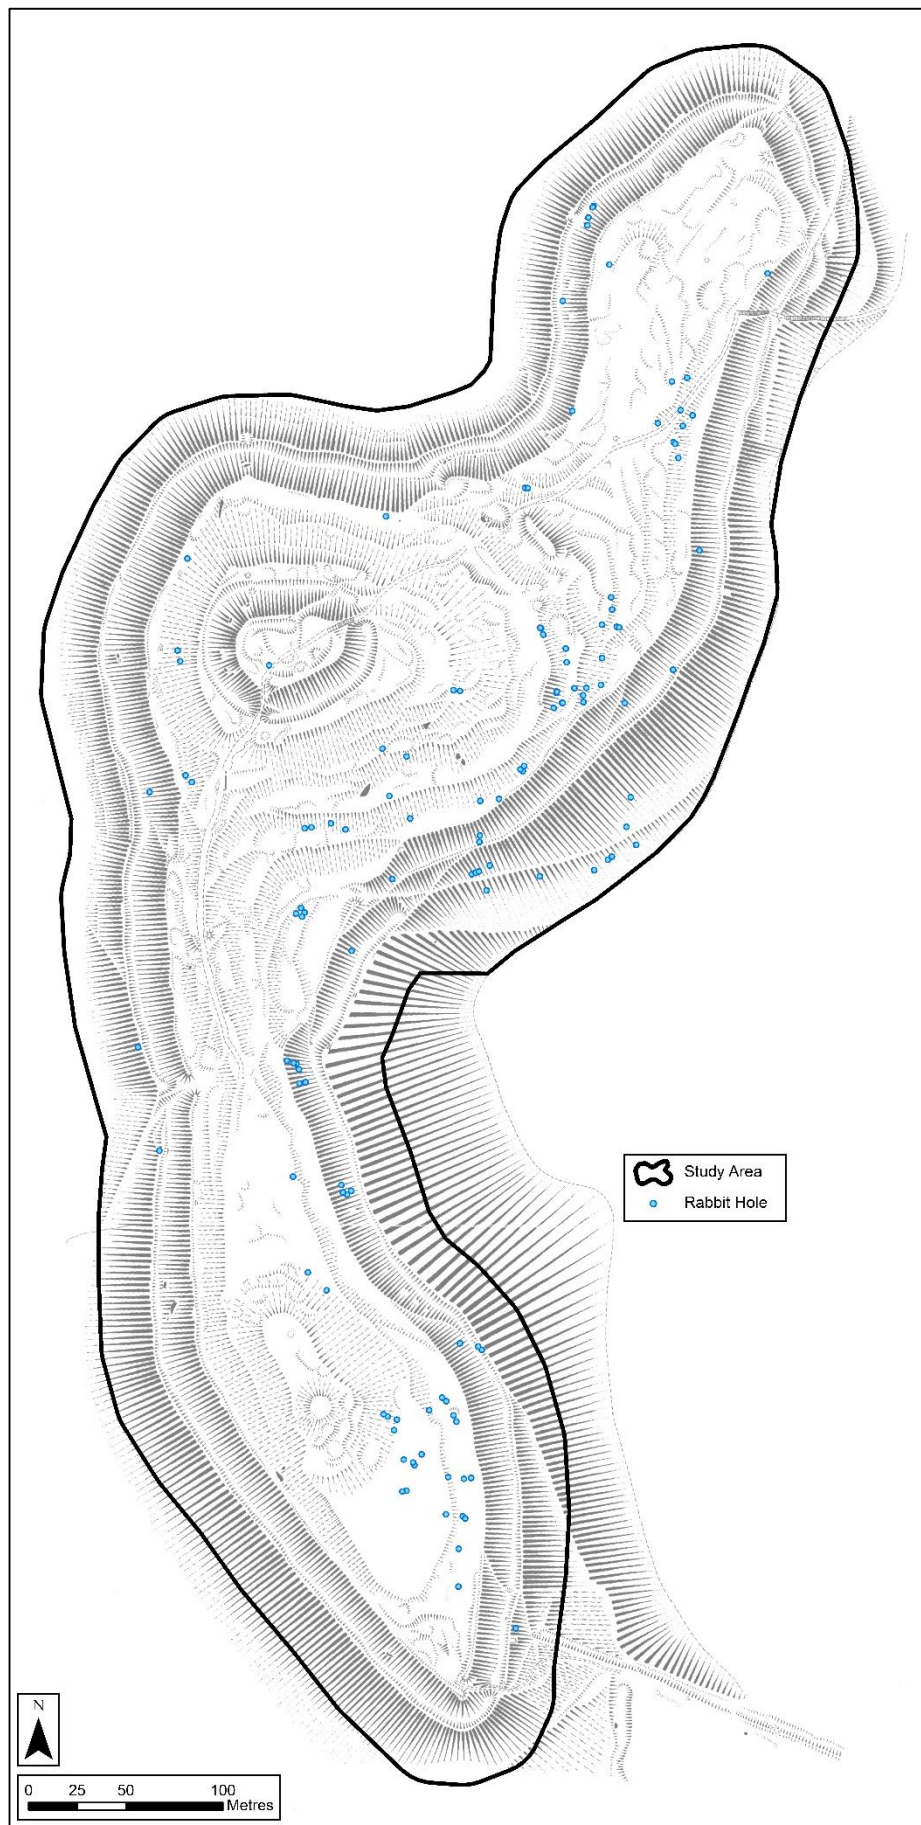
Figure 10: Survey Results of Rabbit Holes

Rabbit burrows are concentrated on the eastern side of the monument (figure 10), and scattered rabbit damage is also most evident on the eastern side (figure 11). Intensive rabbit damage, such as shown in the top right and bottom left photographs in figure 21, is most obvious on the summit and eastern side of Herefordshire Beacon on the slopes of the ramparts (figure 12). Dorling highlighted one main area of rabbit damage on the south-eastern side of Herefordshire Beacon and also indicated that there were other less significant areas of damage across the rest of the monument. It would appear when comparing figures 7 and 13 that more damage has been caused as a result of rabbit activity, especially to the north-east of the monument.

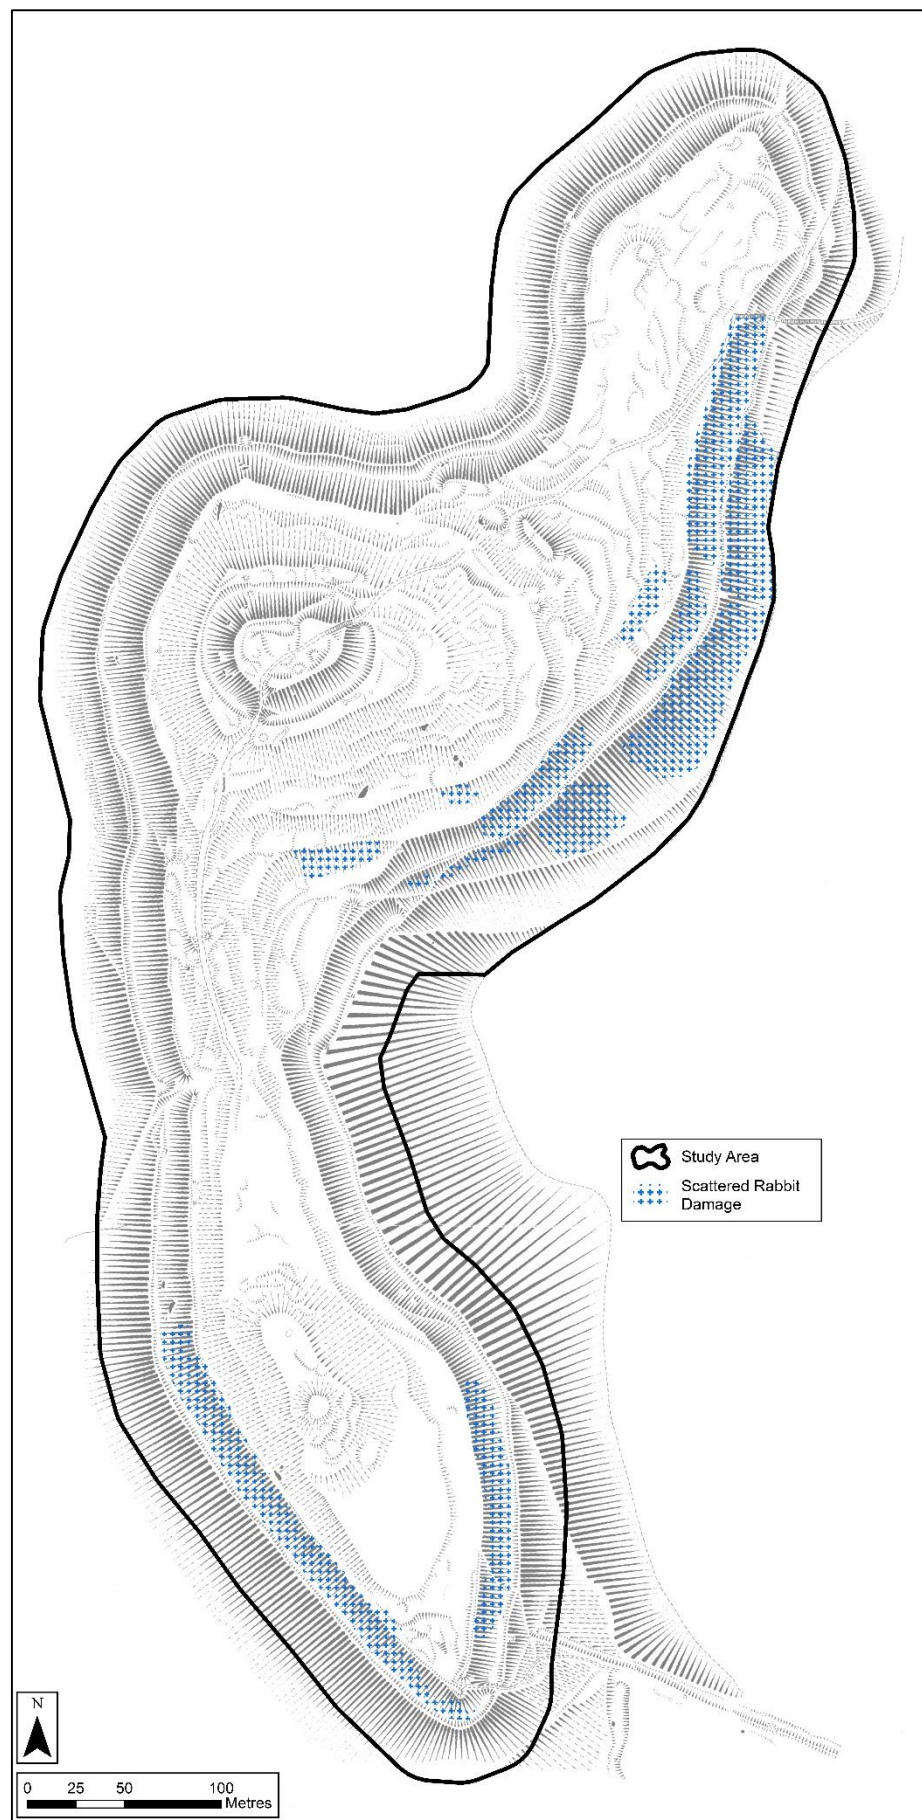
Figure 11: Survey Results of Scattered Rabbit Damage

Scattered rabbit damage is defined as individual burrows close, but not necessarily immediately adjacent to others, whereas intensive rabbit damage was where large areas of erosion were apparent due to a concentrated rabbit population.

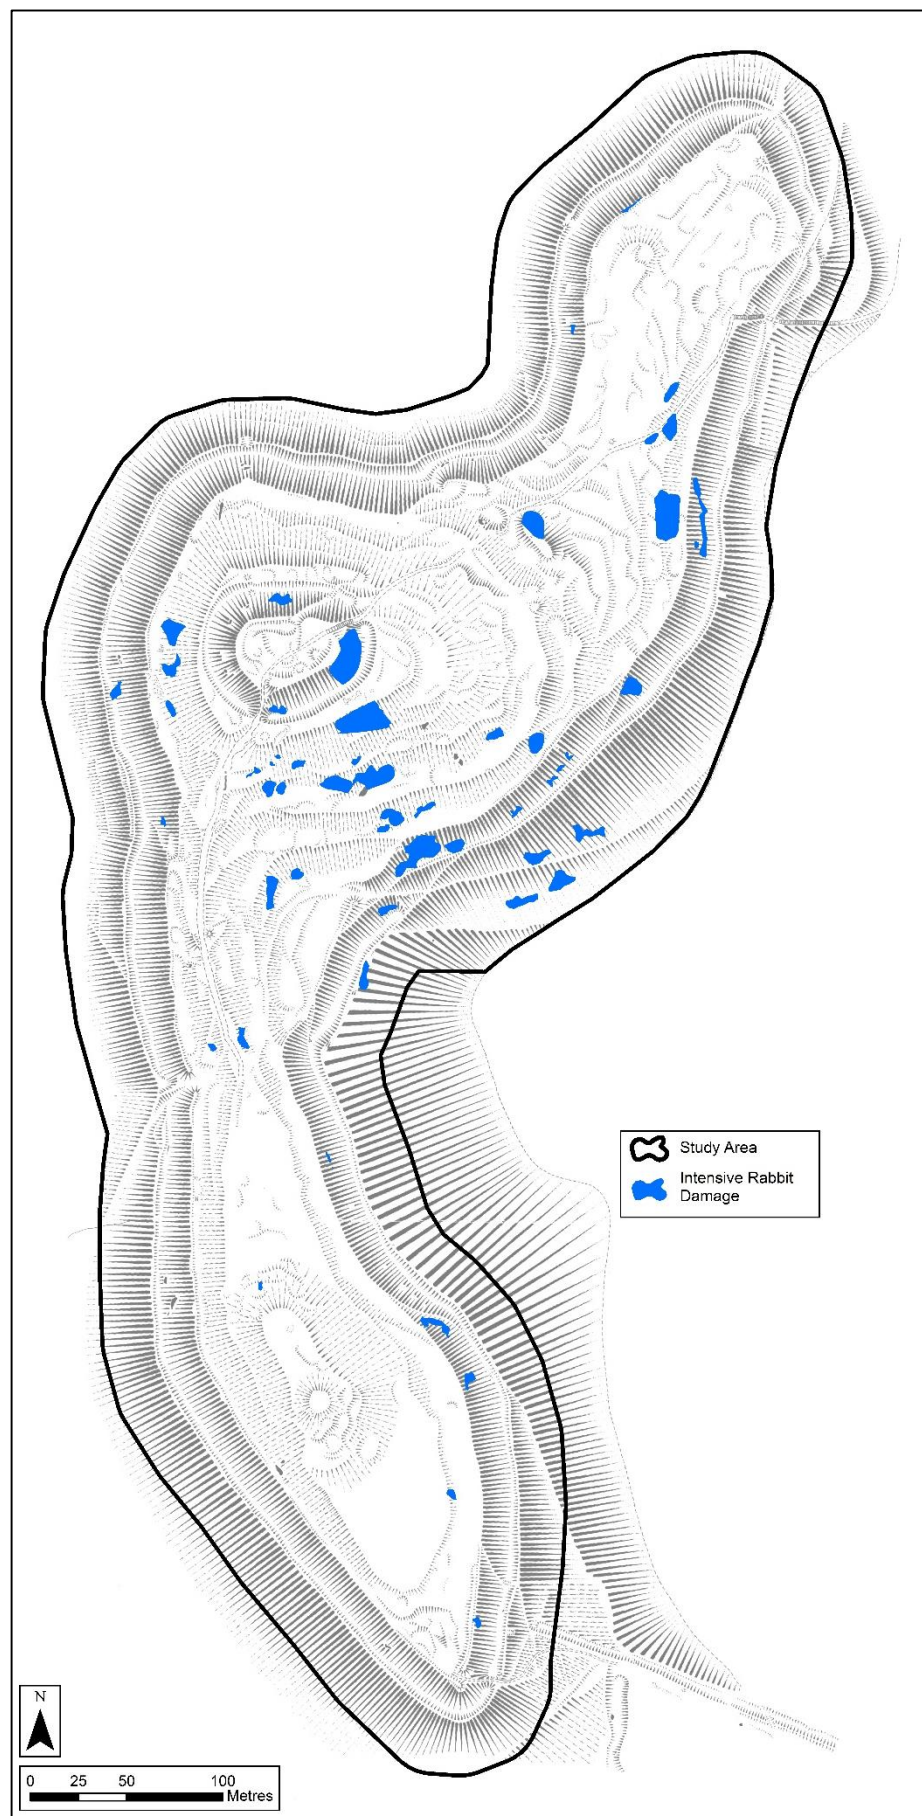
Figure 12: Survey Results of Intensive Rabbit Damage

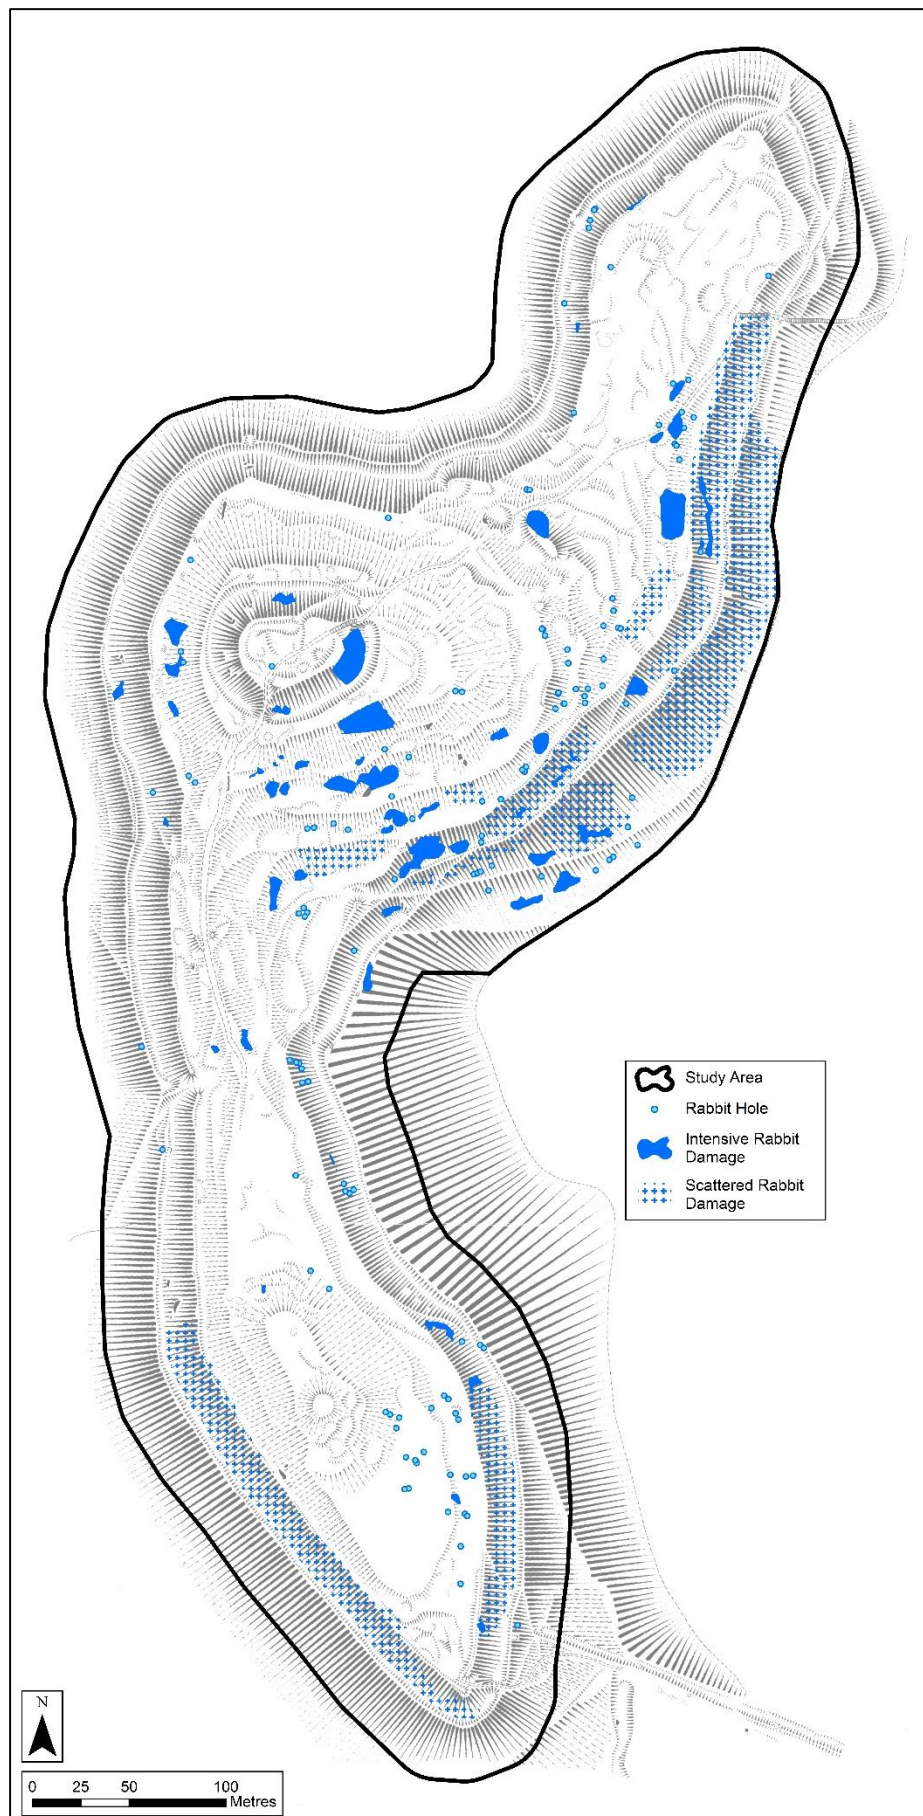
Figure 13: Combined rabbit holes, scattered and intensive rabbit damage

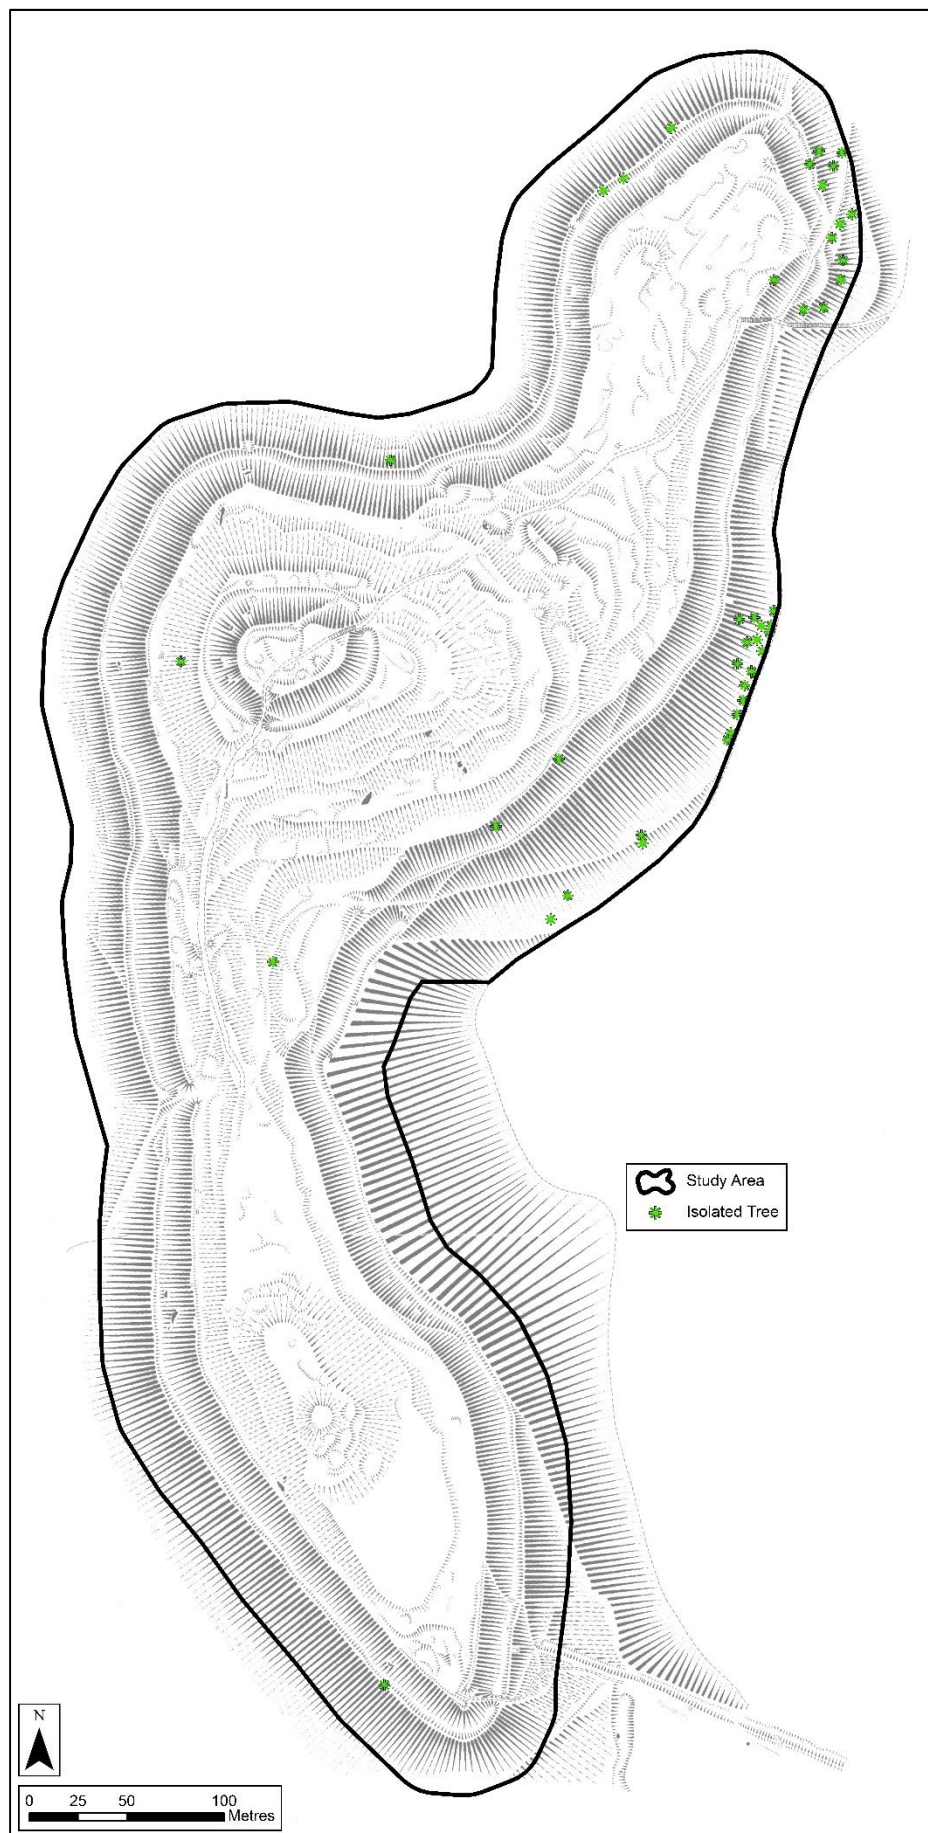
Figure 14: Locations of Isolated Trees

A number of isolated trees were recorded within the study area, and these are mostly located on the lower reaches of the eastern side of the monument (figures 14 and 23). Figure 30 in the appendix highlights the areas of denser tree cover, which in comparison is on the western side and extends down over the slopes.

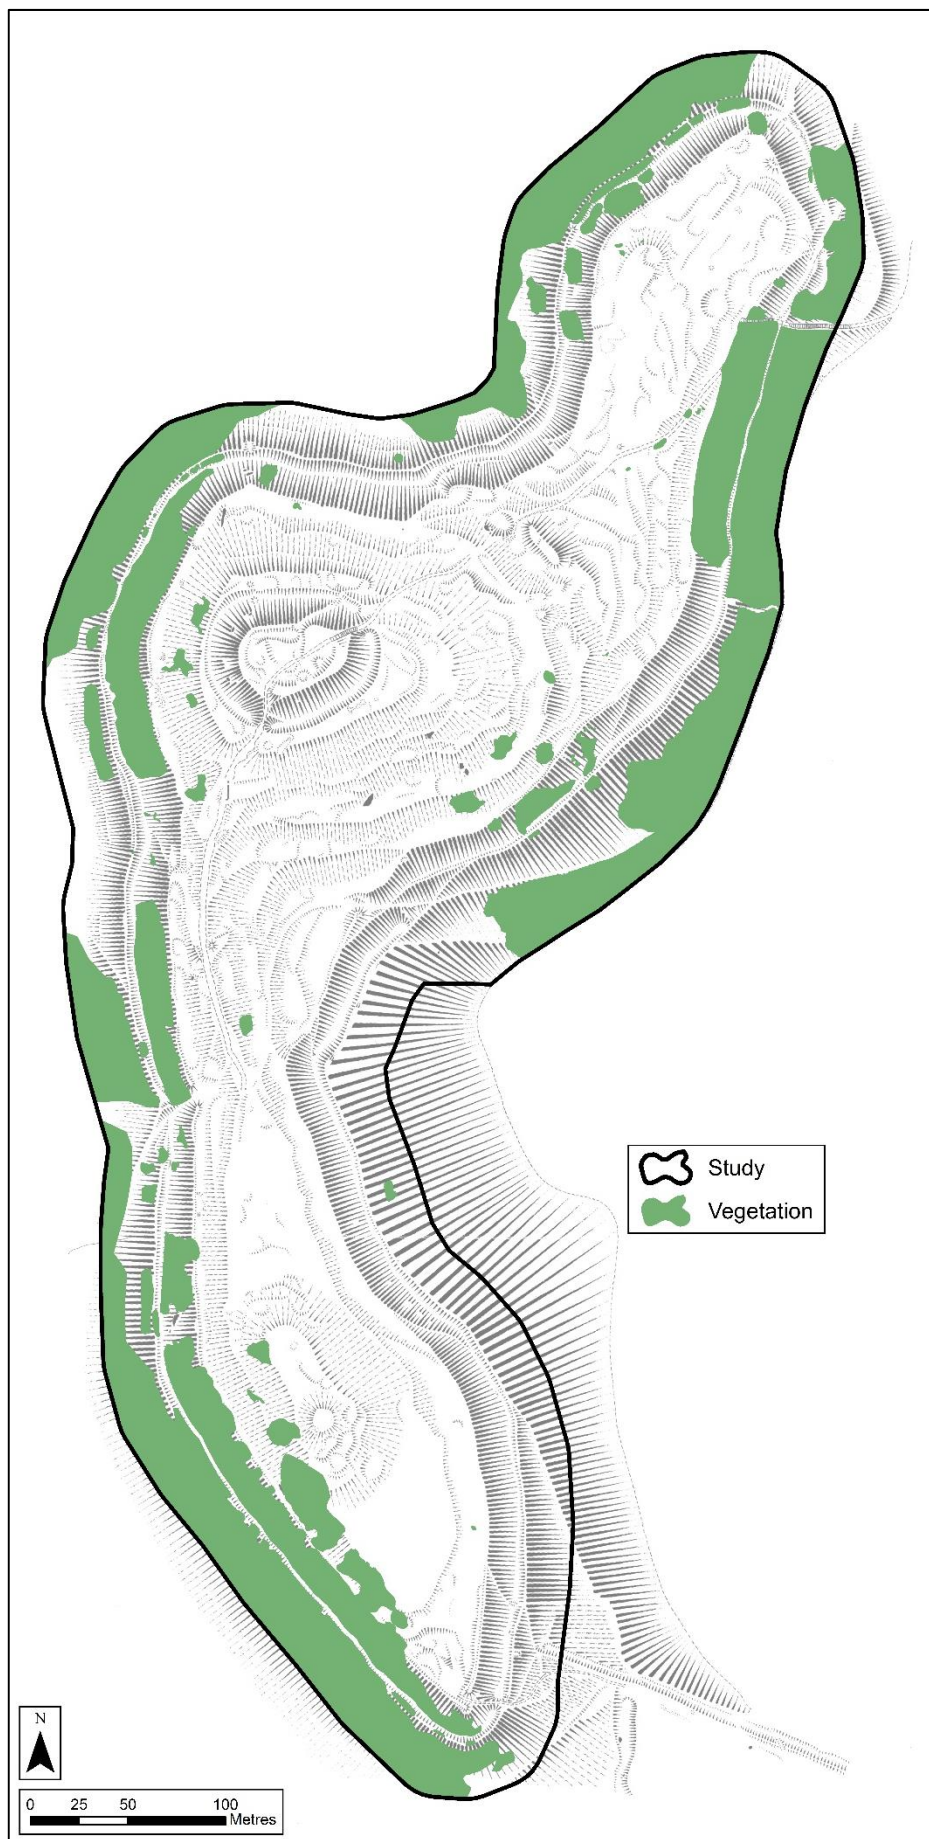
Figure 15: Total Vegetation Cover excluding Isolated Trees

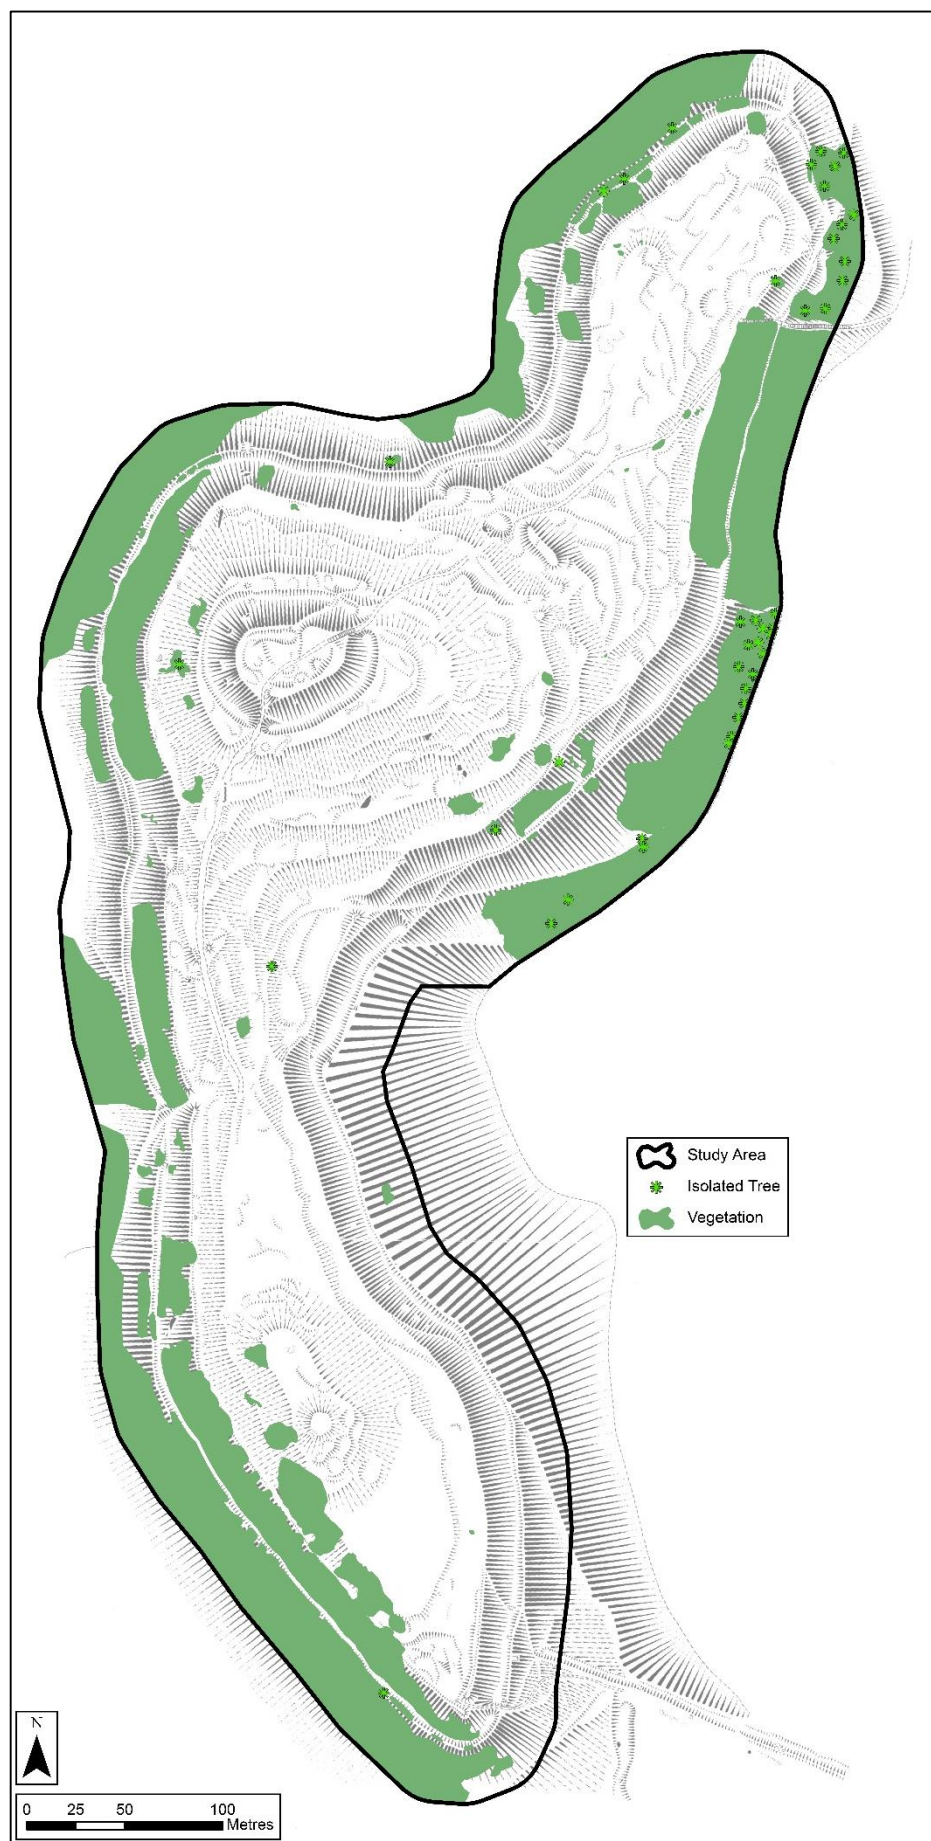
Figure 16: Total vegetation cover including isolated trees

There is abundant vegetation across the whole of the monument, ranging from trees to bracken and gorse. Figure 16 illustrates all vegetation cover, including the isolated trees recorded during the survey, and the appendix includes maps of the different types of vegetation recorded during the GPS survey which comprises bracken, gorse, brambles, Rosebay Willowherb and trees.

There are small pockets of vegetation around the upper ramparts of Herefordshire Beacon and along Millennium Hill, but most vegetation is located around the periphery of the monument on the lower ramparts, specifically along the western edge and north-east. It is apparent that the vegetation is beginning to move upwards

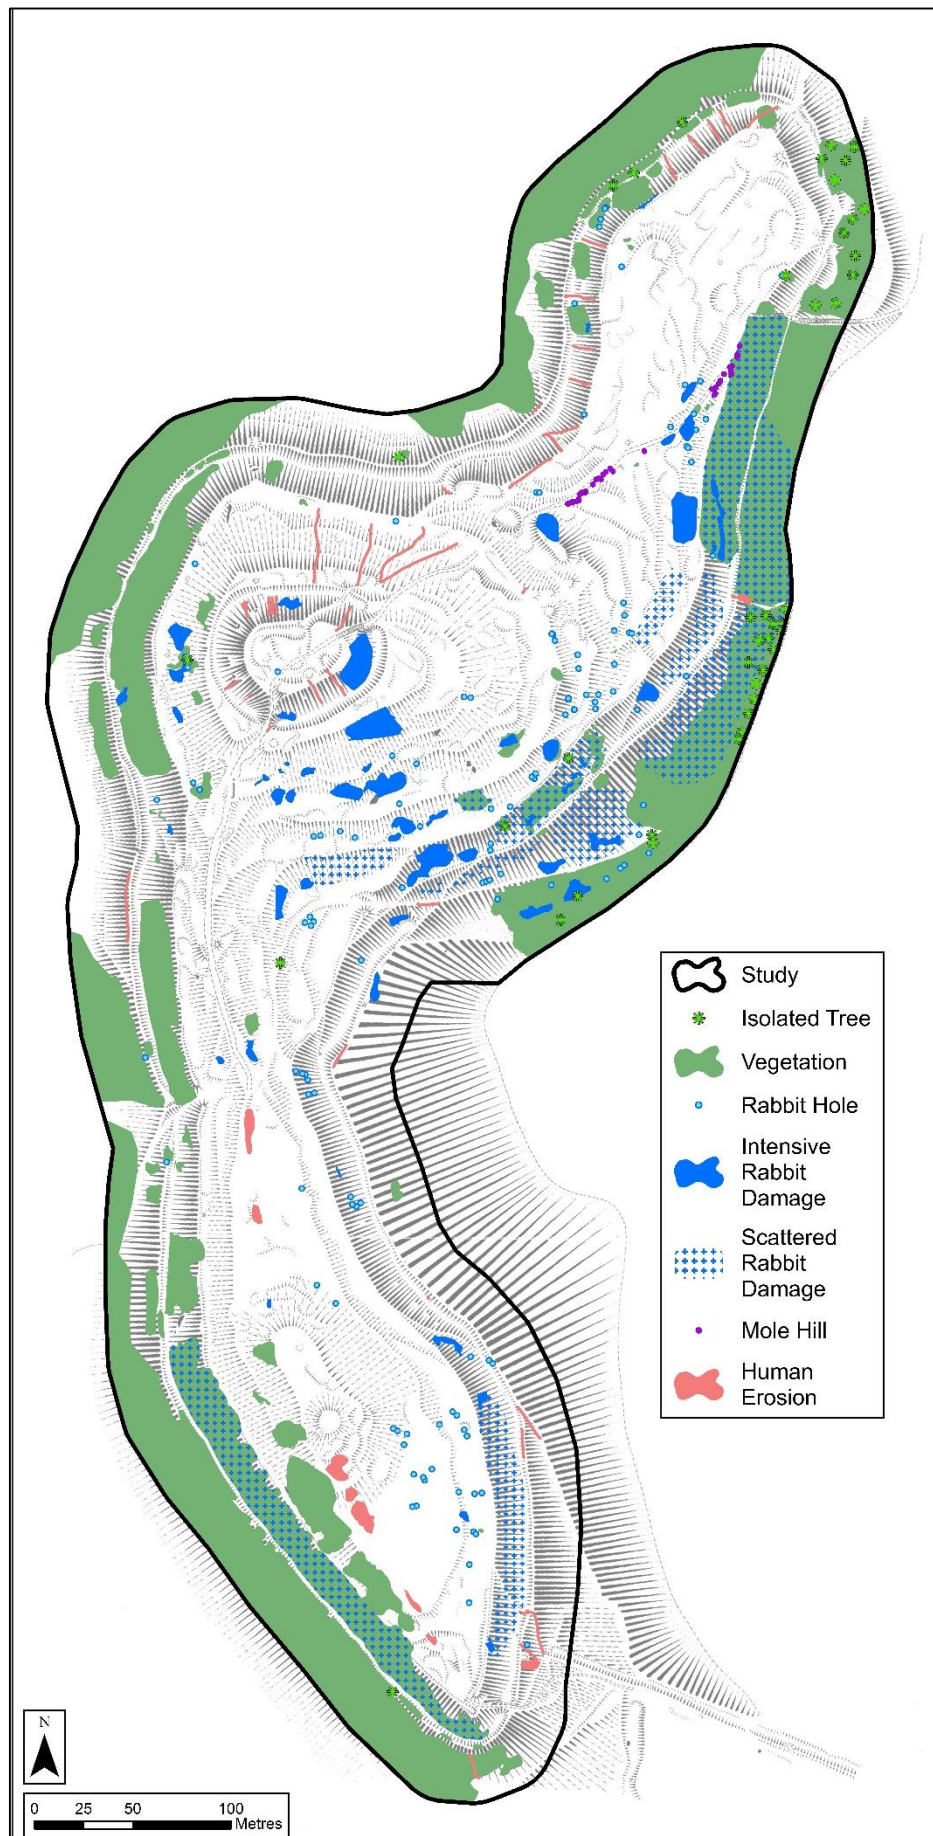
**Figure 17: Total recorded threats and erosion**

Rabbit damage is worsened by foot or bike traffic which exacerbates erosion - areas such as the Citadel clearly show this (figure 17).

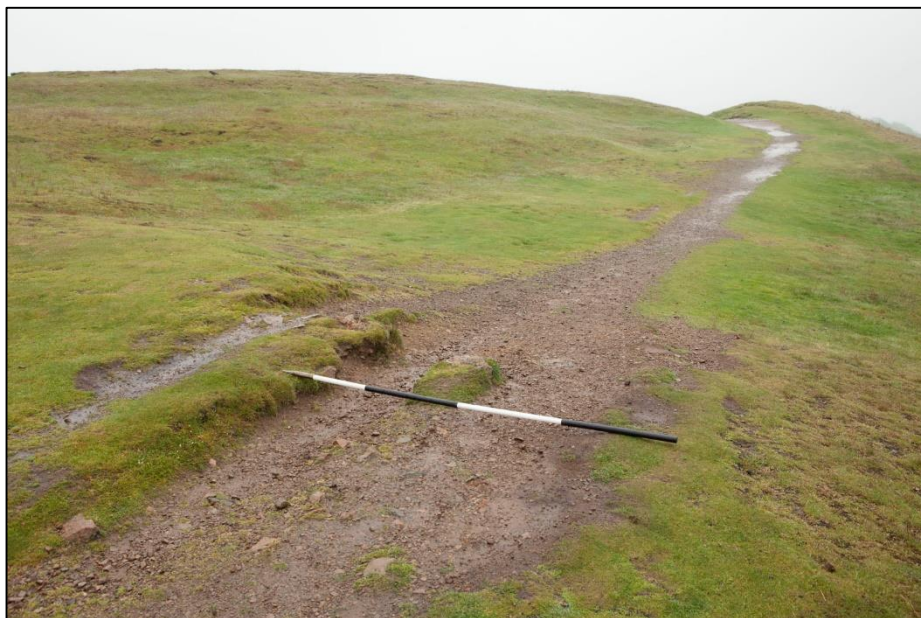
Figure 18: Visible erosion along footpath

Humans cause wear to the surface of the ground, but do not necessarily cause significant damage to the archaeological integrity of the monument (Rimmington 2004). The entrenching of paths and routes through continued use, however, does

lead to significant damage and erosion of archaeological deposits as well as alterations to the profiles and setting of the earthworks (figures 18-20).
